DAILY TRANSMITTER LOG FOR KOKS 89.5 FM - POPLAR BLUFF, MO.

**ATTACHMENT C**

**INDIVIDUAL REPORTS  
ON  
HOMEOWNER RECEIVING EQUIPMENT**

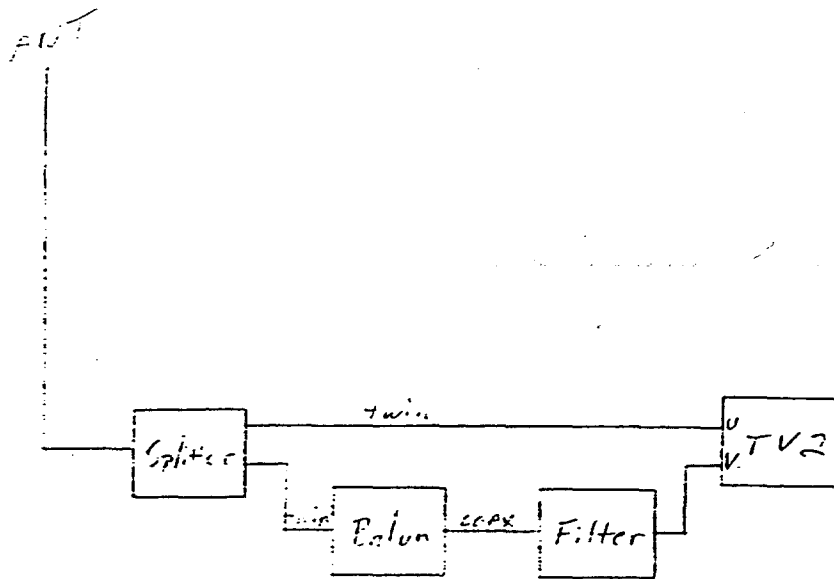
Notes: KOKS would not fix smaller TV sets. The magnavox TV previously used twin lead, now using coax. Mrs. Smith was not convinced KOKS was off the air, even with spectrum analyser showing station off the air. She based her conclusions on the stereo light on her Magnavox radio which was still lit when station was taken off the air. When TV reception did not clear up as she anticipated, she also began questioning whether radio station KKLR was also contributing to the reception problem. We came back to this residence on 2/13/92 and had KOKS and KKLR go off the air. This resulted in no improvement in the TV picture. The magnavox television seemed to have difficulty tuning in some of the channels. All of the television sets had severe audio rectification problems with KOKS on the air. The measured field strength near this residence was 1,750mv/m.

KOKS failed to restore quality of television and radio reception at this residence. The magnavox TV is now utilizing coax cable and one notch filter. It has more insertion loss than the twin lead wiring previously used at the time the IX began. There was slight improvement on one portable TV when KOKS stopped transmissions.

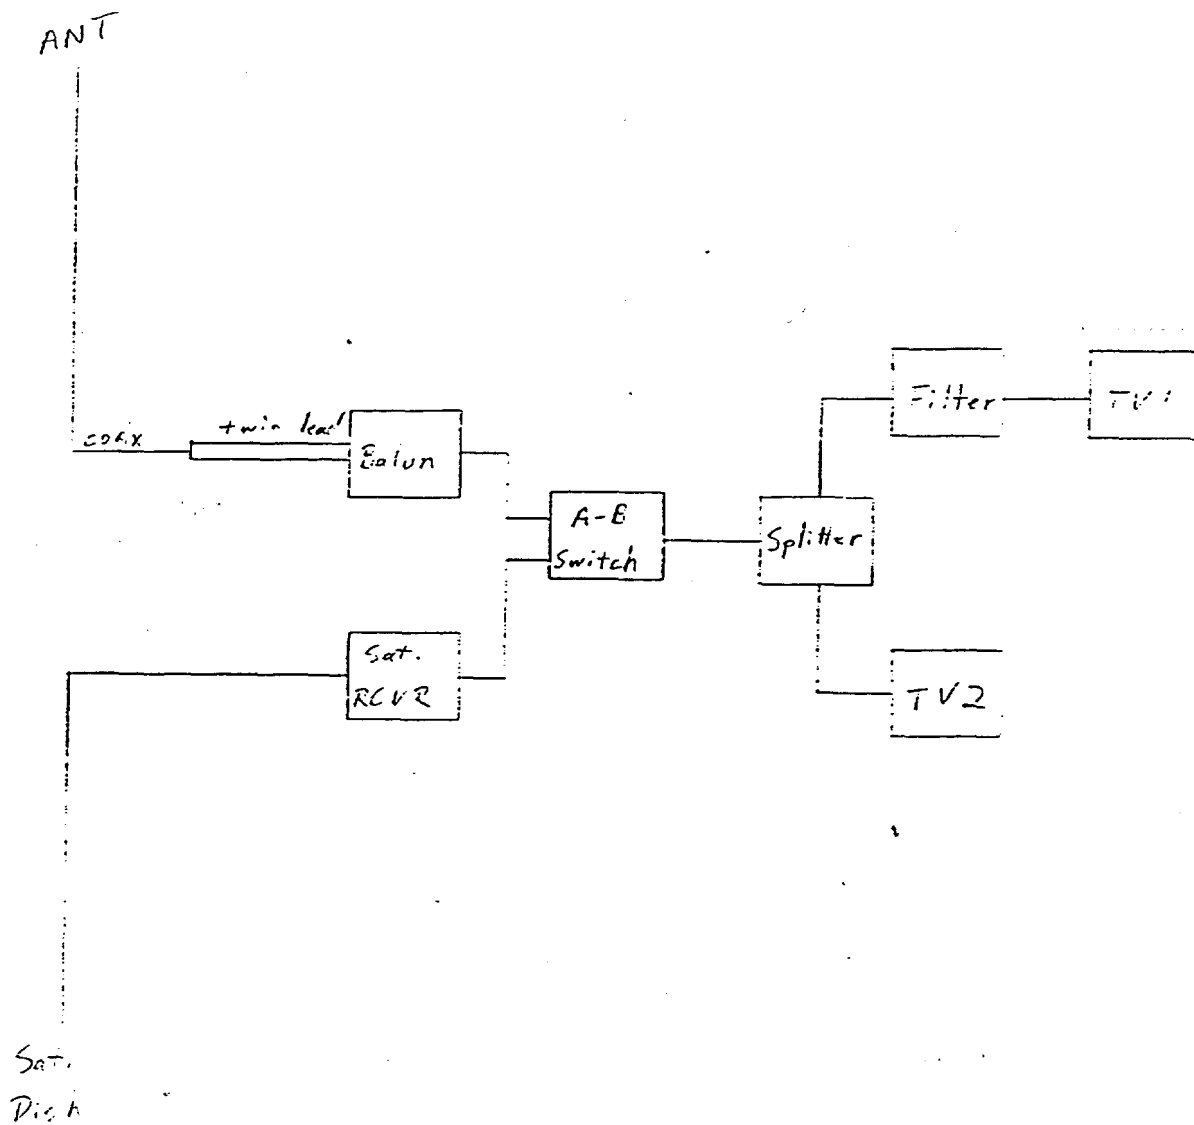
\*\*\*\*\*  
 Notes: The coax installed by KOKS personnel which is spliced to twin lead does not use a balun. Audio rectification on TV's and stereo. The Hillis's stated that KOKS would not filter the stereo or the portable TV. When the TV pictures did not clear up as they expected, Mr. Hillis wanted to know if KOKS was "jamming" him with some other device since his stereo light remained lit when the station went off the air. Mrs. Hillis questioned whether radio KKLR could be contributing to the IX. On 2/13/92 we came back to this residence and had both KOKS and KKLR go off the air. The picture quality did not improve. The measured field strength near this residence was 1,750mv/m.  
 \*\*\*\*\*

KOKS failed to restore the quality of television reception at this residence. Picture quality increased when KOKS discontinued transmissions. Occupants must be pointed toward KOKS tower for reception of Ch.6 and Ch.12 television signals.

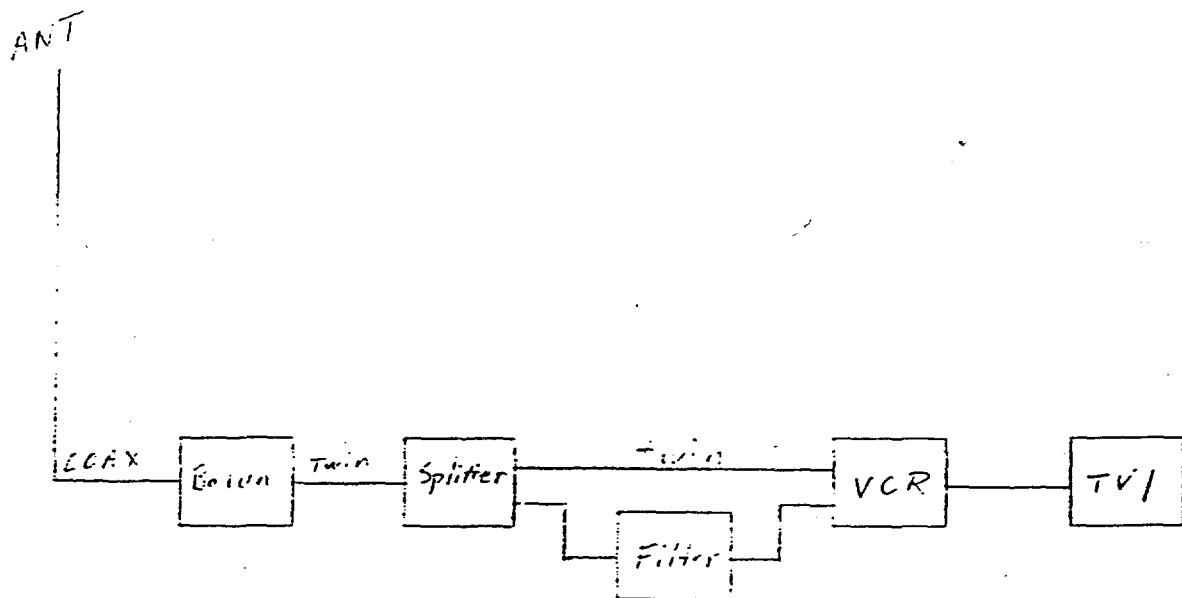
KOKS failed to restore quality of picture reception at time complaint was filed. Since that time occupant has installed a new antenna and coax. With the increase in insertion loss using the coax cable and a filter, the already weak TV signals are not strong enough with existing equipment to produce a g' picture. In addition, the TV antenna must be pointed directly at the KOKS tower to receive the Ch.6 and Ch.12 TV signals.

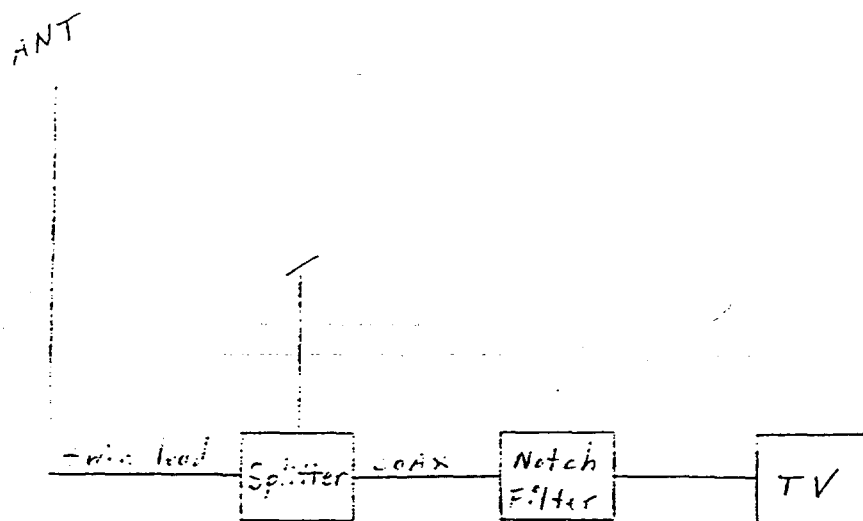
\*\*\*\*\*  
otes: The filter installed by KOKS quit working after a couple weeks so Ms. ynn purchased her own. She stated that she called KOKS asking them to pay or the filter she purchased, but they refused. The field strength at this esidence was 860mv/m.

KOKS improved but did not completely restore quality of television reception with the installation of one notch filter. The filter quit working after a couple weeks. After filter quit the occupant purchased her own filter. KOKS did not attempt to restore radio reception. Picture quality improved when KC stopped transmissions. The occupants TV antenna must point toward the KOKS tower to receive Ch.6 and Ch.12 TV signals.

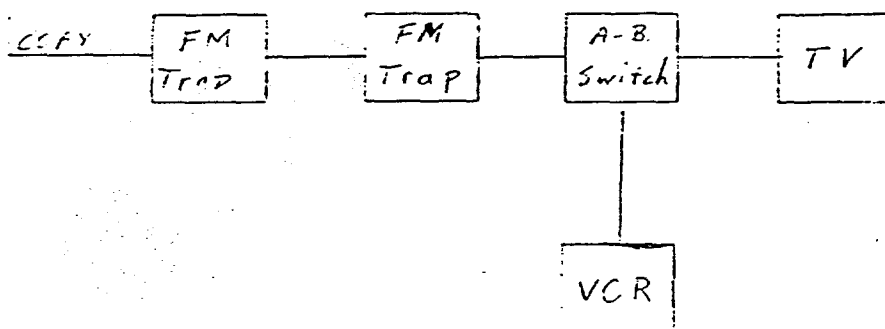
Notes: At her own expense, and after KOKS had failed to correct the IX, Mrs. Piper paid Mr. Lampe (KOKS Engineer) to try and eliminate the IX. She paid for new coax from the antenna to TV, and for two Archer FM Traps. The field strength at this location was 860mv/m.

KOKS failed to restore quality of television reception at this residence.

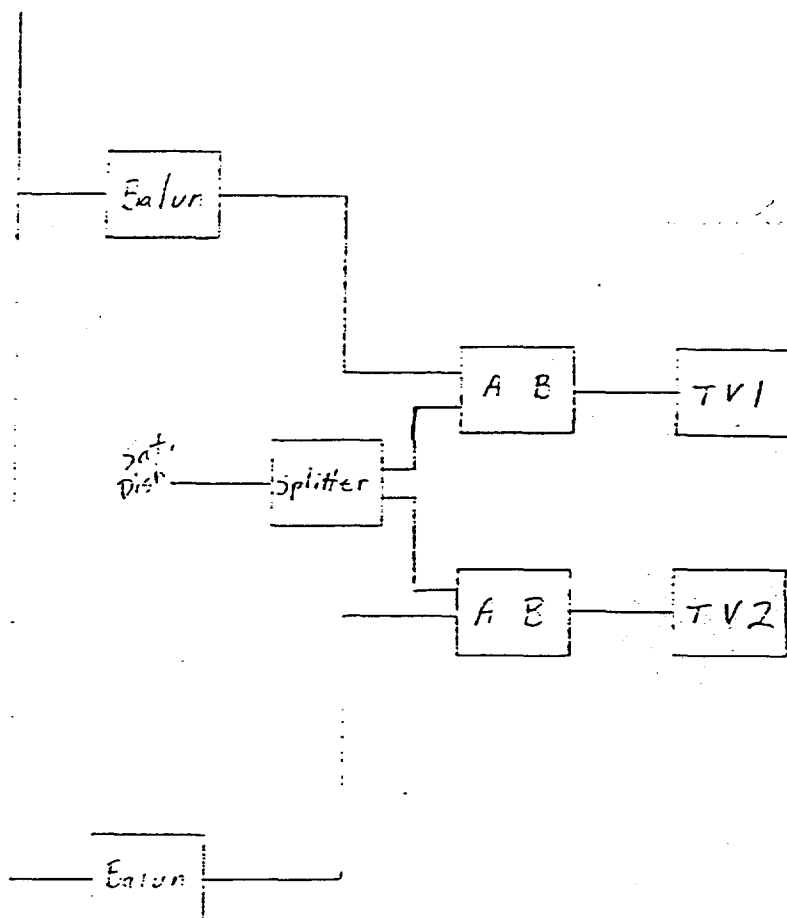
Notes: The measured field strength at this residence was 1,720mv/m.  
Occupant has installed a sattelite receiving system.

KOKS failed to restore the quality of television reception, so the occupant installed sattelite receiving equipment and A/B switches to switch between off the air stations and satelllite reception. With the current TV receiving equipment there was no apparent change in picture quality when KOKS stopped tr  
issions.

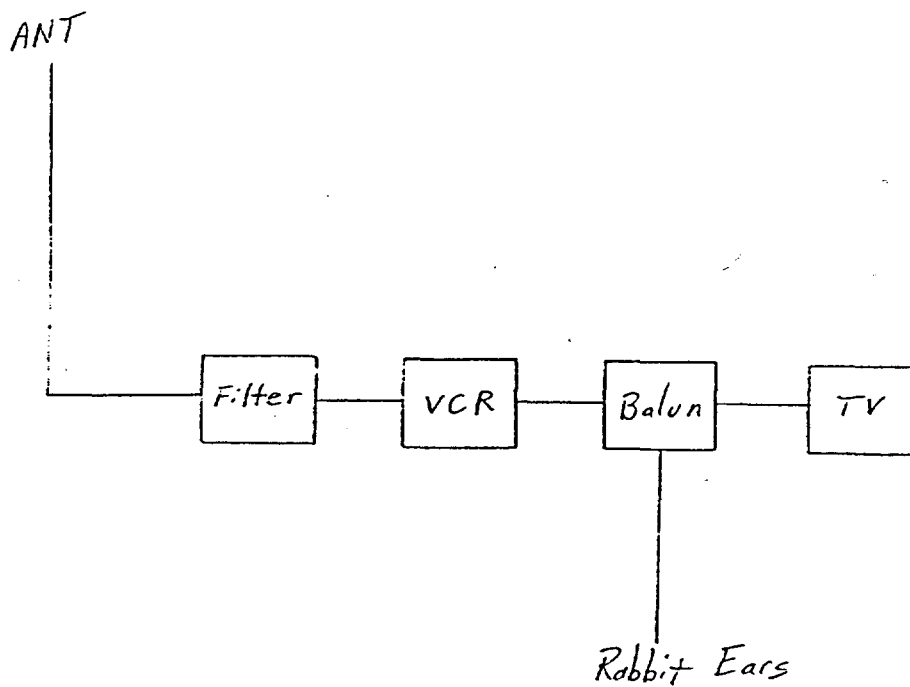
\*\*\*\*\*  
 Notes: The Kearbey's installed the Archer FM Trap KOKS had provided at their previous address. The antenna used at this residence was pointed 180 degrees from the Channel 12 and Channel 6 TV stations, and it was lower than the roof and obstructed from direct reception of those signals. The current residence location of the Kearbey's is approx. 2 miles due east of the KOKS tower.  
 \*\*\*\*\*

KOKS failed to restore quality of television reception at the time complaint was filed. Since that time the complainant has moved to another residence within the 2.45 mile radius of the KOKS tower. At their current residence the TV antenna is pointed 180 degrees away from the Ch.6 and Ch.12 TV signal sources. No improvement of TV picture could be detected with existing TV receiving apparatus.

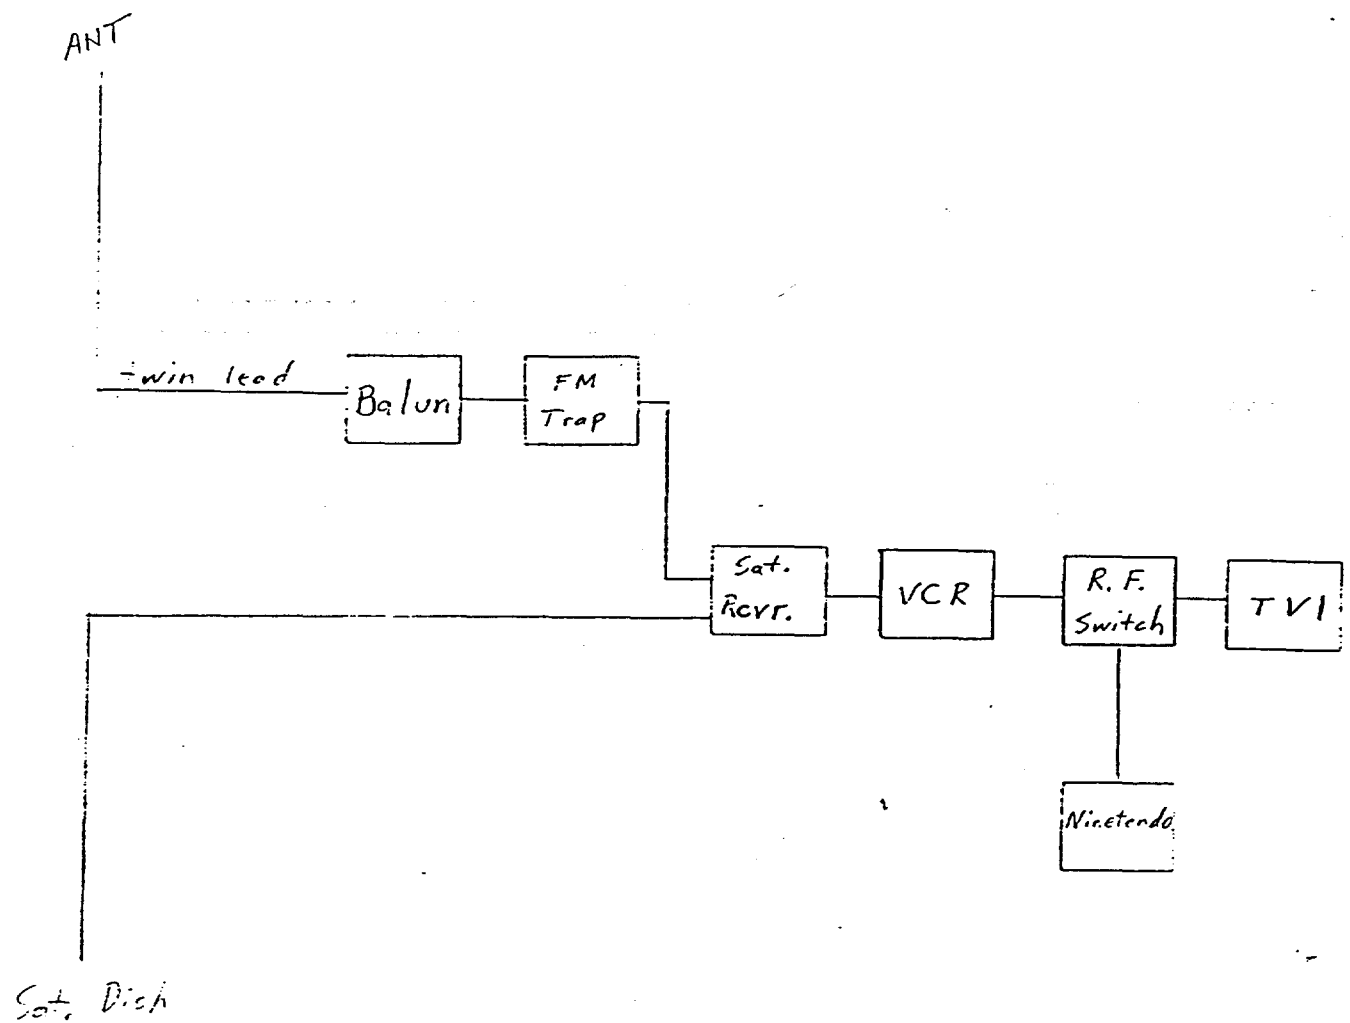
Notes: The field strength measured at this location was 409mv/m. This residence is approx. 1.5 miles east of the KOKS tower.

KOKS failed to restore the quality of the TV and radio reception at this residence at the time the complaint was filed. Since that time the occupant has purchased a new television receiver and a satellite receiving system. When viewing off the air TV signals, the quality of pictures improved when KOY discontinued transmissions.

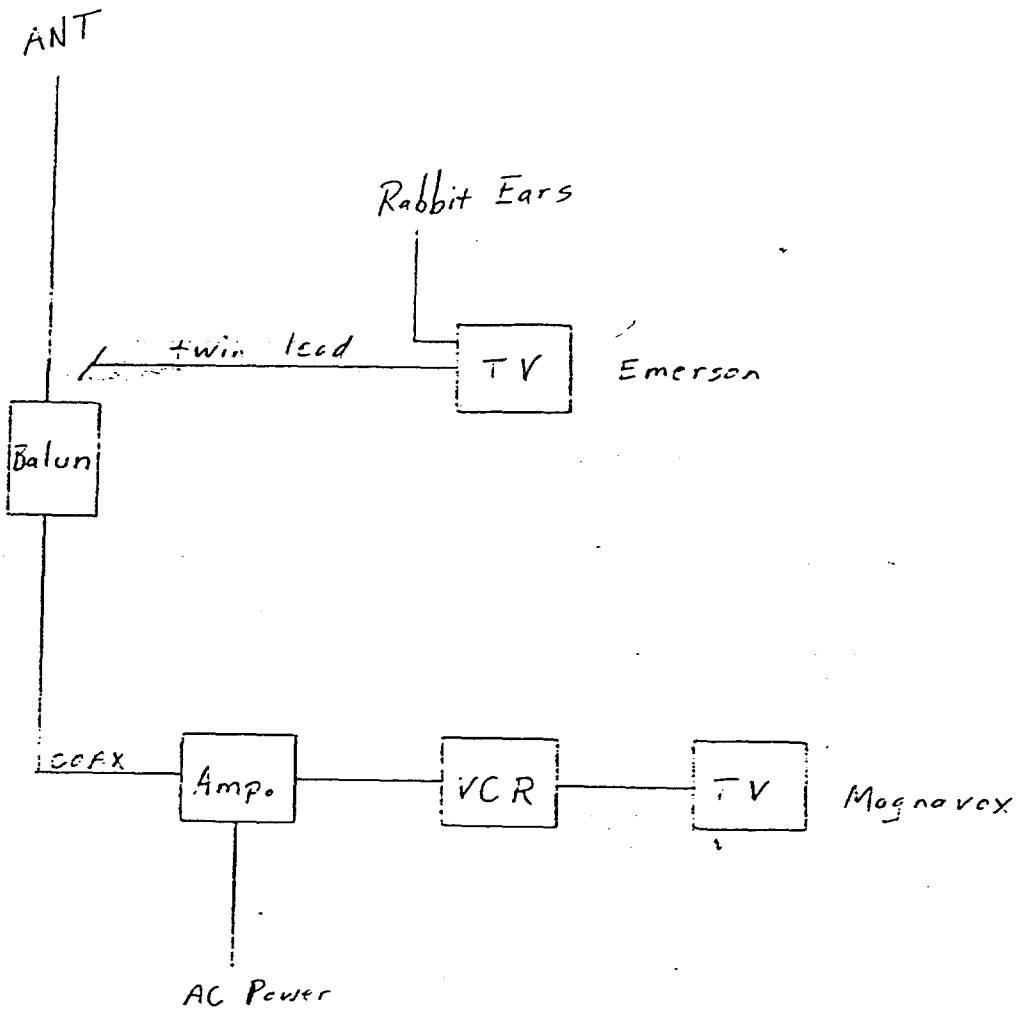
Notes: Mrs. Freeman thought the Emerson TV was connected to the directional antenna, but the twin lead had come loose at the antenna. The Magnavox was being used temporarily by Mrs. Freeman, it belongs to her daughter. The field strength at this location was 2,150mv/m.

KOKS failed to restore quality of picture reception at time complaint was filed. Since that time the occupant's twin lead has broken loose from the directional antenna resulting in poor reception on the Emerson TV. The other television utilizes a booster amplifier. This TV had a greatly improved quality of picture when KOKS stopped transmitting. The field strength at this location was higher than any other location visited.
